Manhole Inspection Summary

Manhole # S47A__021MH

Location Address: **Jefferson**

Cross Street: **Duncan**

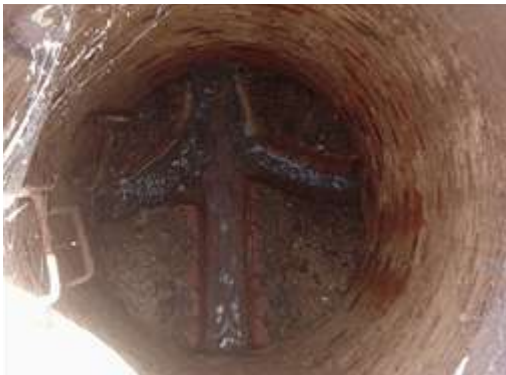
Defect 2

infiltration

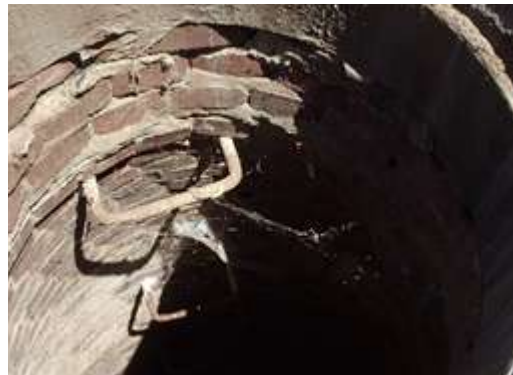
Defect 1

deterioration

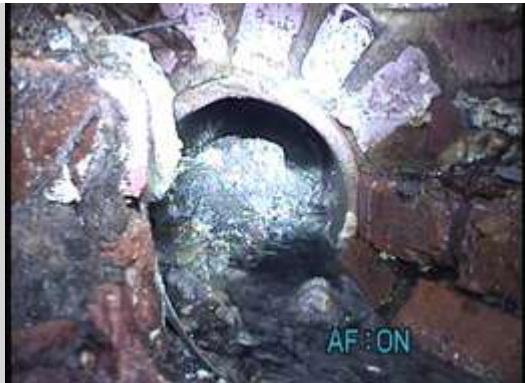
9 O'Clock Inflow

Deposits: ☐ None ☐ Mud ☐ Sludge ☒ **Debris** ☐ Grease

Silt Depth: **5** (in.) Deposits Extent: **Heavy**
